Test Report

Product : Mode Key Selector Switch
Model No. : NS22-MKP-2B02A RL
Manufacturer /Address : Kun Hung Electric Co., Ltd. / 183, Hancheon-ro, Dongdaemun-gu, Seoul, 02534 Republic of Korea

4. Test standard (method) used : IEC 60068-2-6: 2008, IEC 60068-2-27: 2008,
IEC 60529: 1989+A1:1999+A2:2013
Requested test standard by applicant (Section * 5.2)

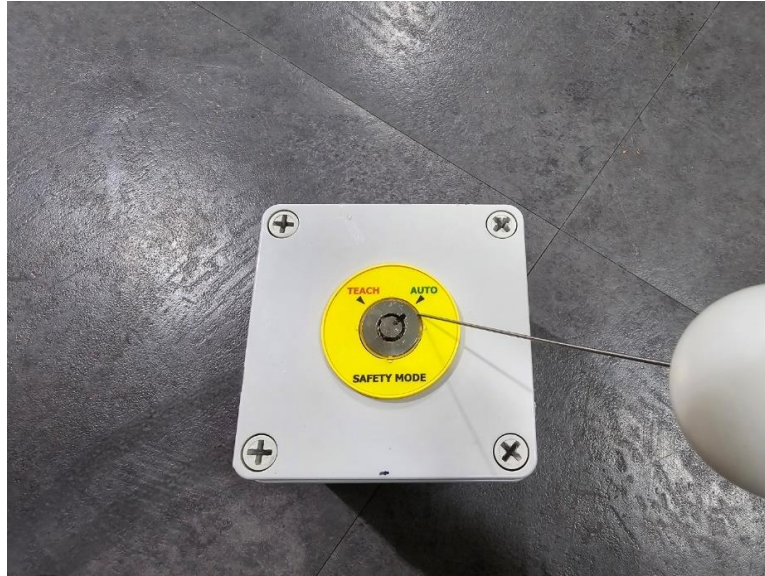
[Against access to hazardous parts with protected]

First characteristic numeral	Degree of protection	Remarks
6	Protected against access to hazardous parts with a wire. The access probe of 1.0 mmØ, shall not penetrate. Test force: 1 N ± 10 %	(Test conditions, see 5.1.7)

IP code	Separation	Result
IP 6X	Access	There was a not penetration of probe.
	Foreign objects	There was a not ingress of dust.
IP X6	water	There was a not ingress of water.

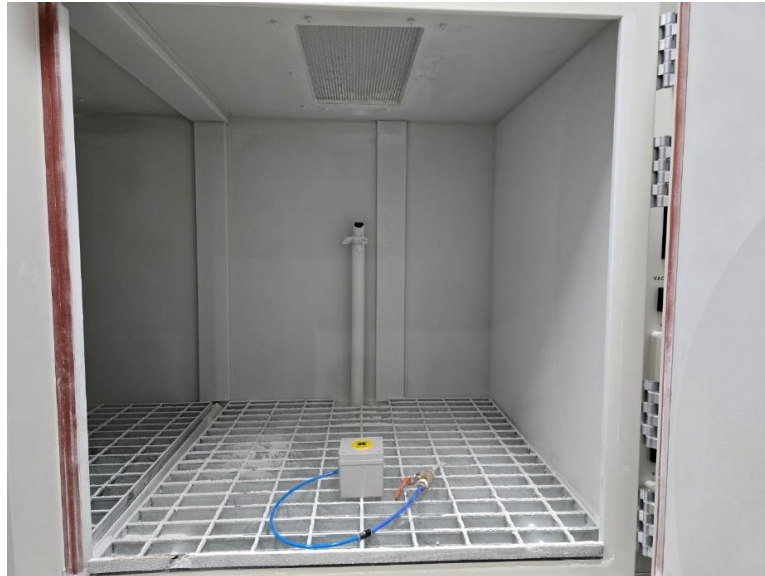
[Against ingress of solid foreign objects protected]

First characteristic numeral	Degree of protection	Remarks
6	<p>In Dust Testing Equipment, the test sample has to have no ingress of dust after testing atmospheric pressure present condition for 8 hr. (Talcum powder have to go through the measured sieve by Φ 50 um wire that are spacing 75 um in squared, per volume and union Talcum powder have to be 2 kg/m³)</p> <p>Products in volume : 1 000 cm³ → 1 L</p> <p>Target intake volume (Products in volume : 80) : 80 L</p> <p>Suction volume (Max product in volume 60) : 60 LPH → 1 LPM</p> <p>Actual Suction volume : 1 L</p> <p>Suction pressure (Up to 2 kPa) : 1.8 kPa</p> <p>Test time (Up to 8 time) ; 8 hr</p>	(Test conditions, see 5.1.7)

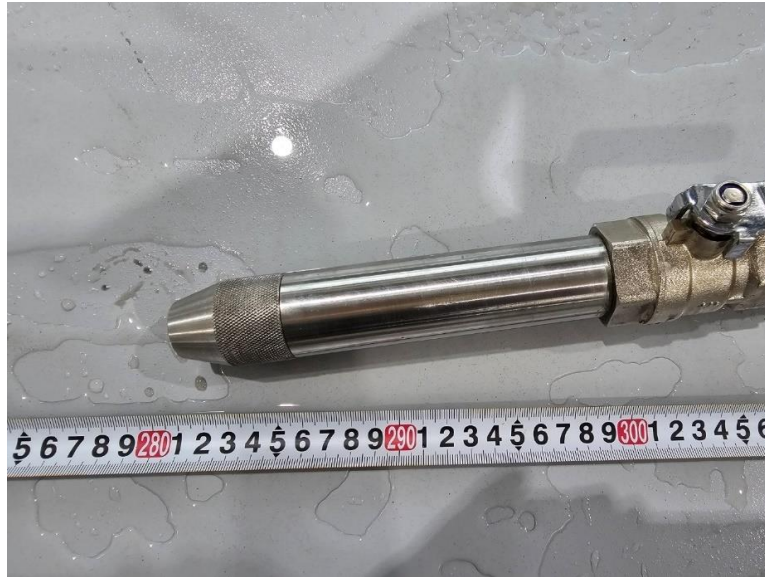
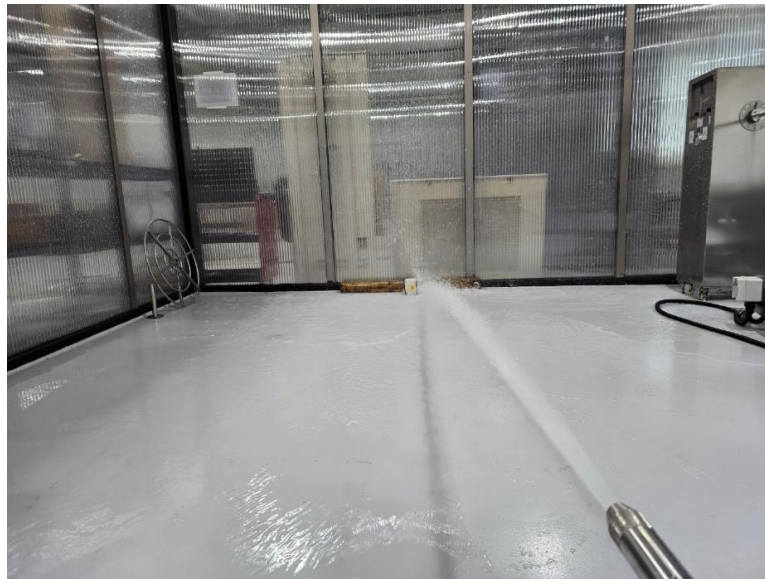
[Second characteristic numeral]

Second characteristic numeral	Degree of protection	Remarks
6	<p>The product must not be harmed in any direction even strong jet water. Inside diameter of Nozzle: 12.5 mm Water flow rate: 100 l/min Distance: 2.5 m to 3 m Duration of test: 1 min/m² at least 3 min</p>	(Test conditions, see 5.1.7)

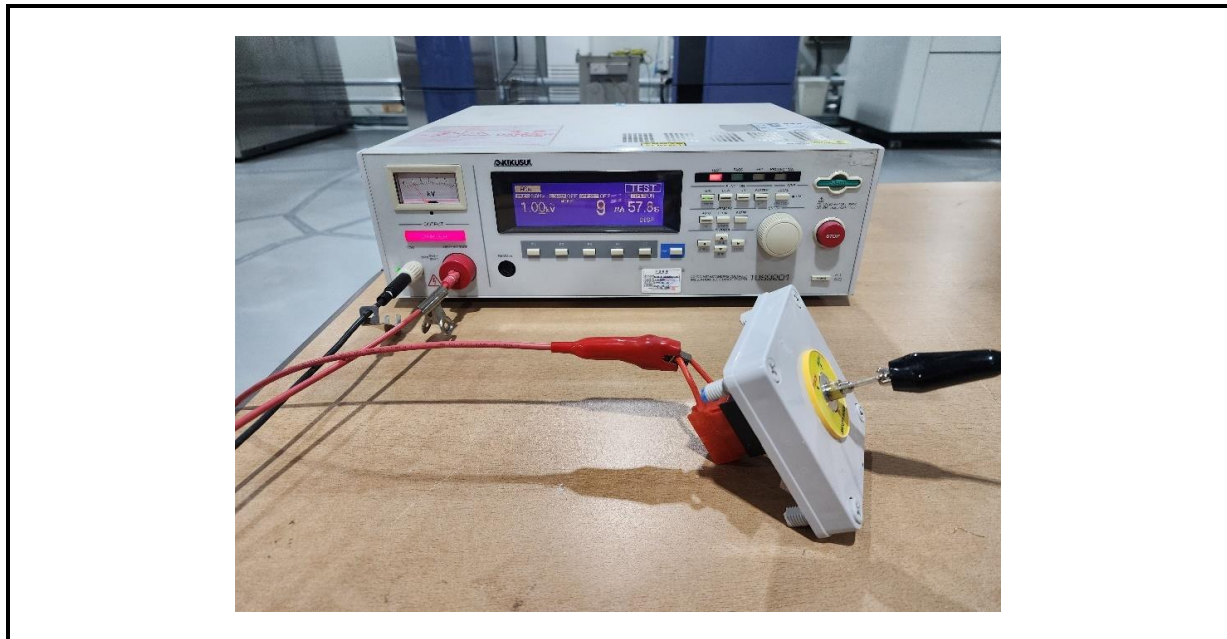
5.2.4. Test photo

Authorized location	applied voltage [V a.c.]	Authorization time [s]	Test standards
Conductive part and frame	1 000	60	If applied at 1,000 V, 60 Hz for 60 s, there shall be no defects in insulation breakdown or use. (Cut off Current : 100 mA)

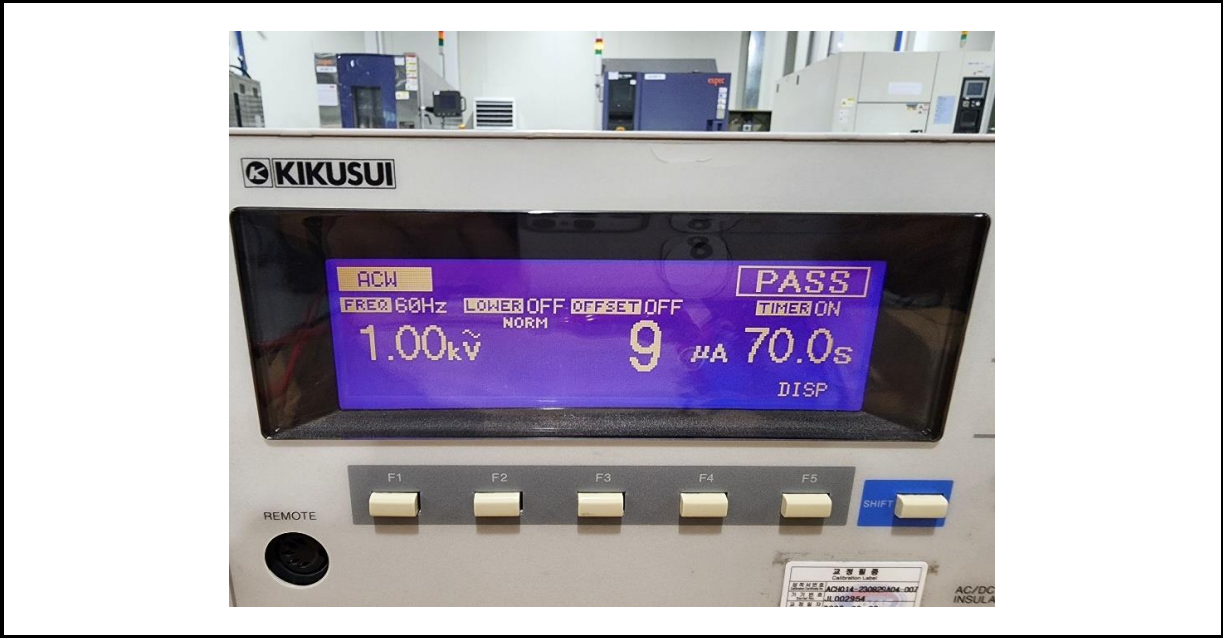
5.2.5. Test data

Test voltage [V a.c]	Test time [s]	Test result
1 000	60	No abnormality was found

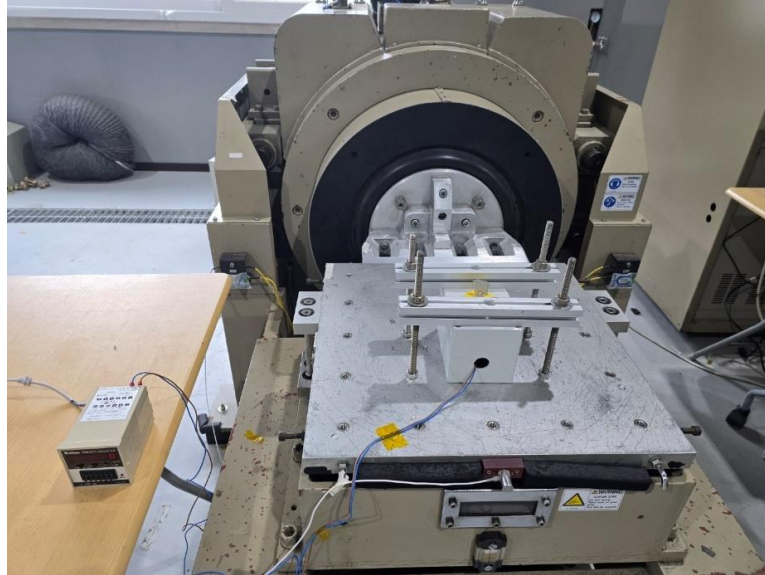
[X axis]

Item	Test Condition
Acceleration (m/s^2 , g)	15 g
Duration (ms)	11 ms
Number of shocks	6 shocks applied in each direction along three mutually perpendicular axes (a total of 36 shocks)
Test type	$\pm X$, $\pm Y$, $\pm Z$ axis
Number of samples	1 EA

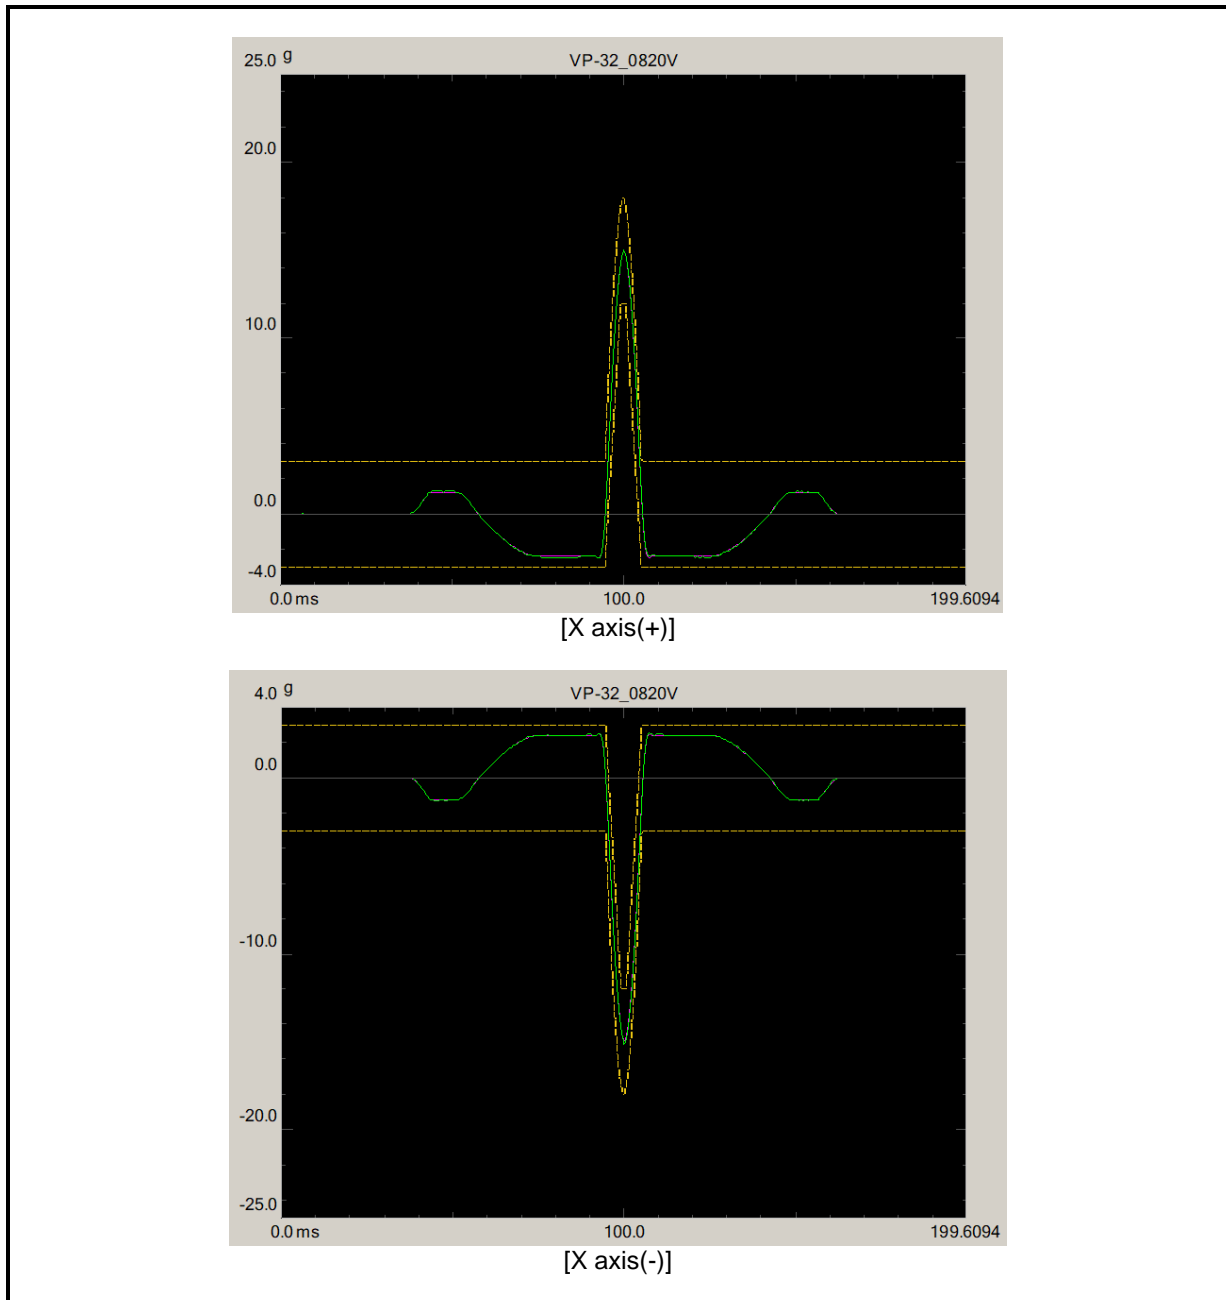
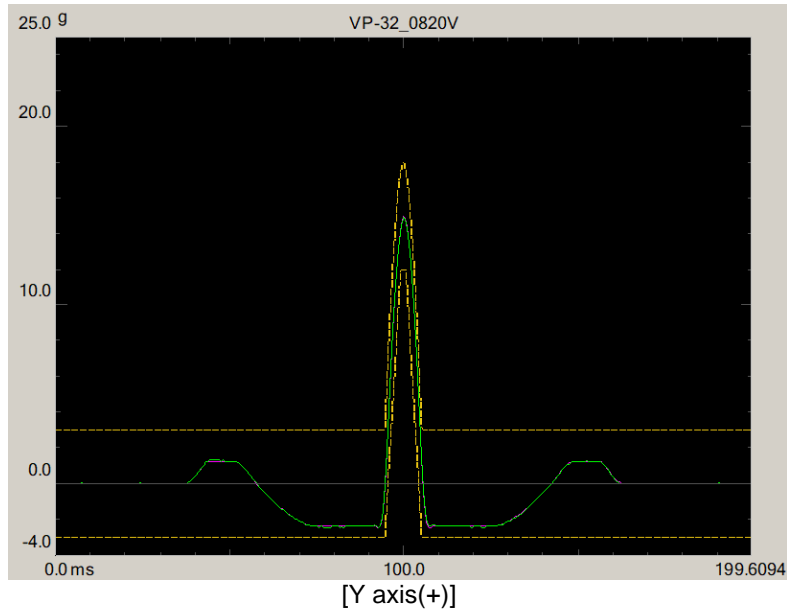
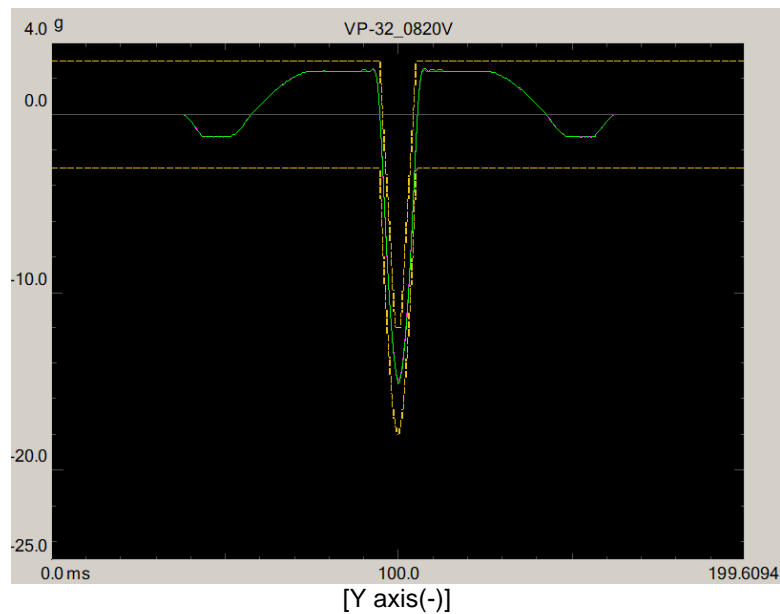
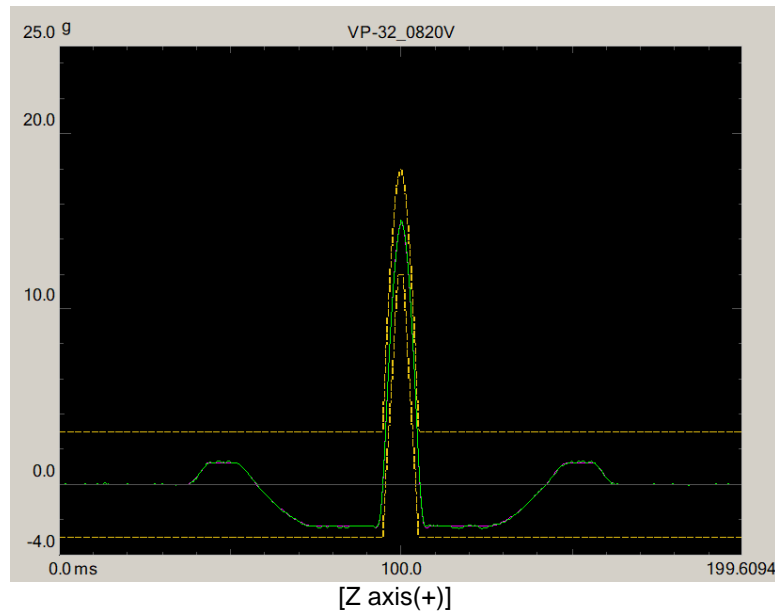
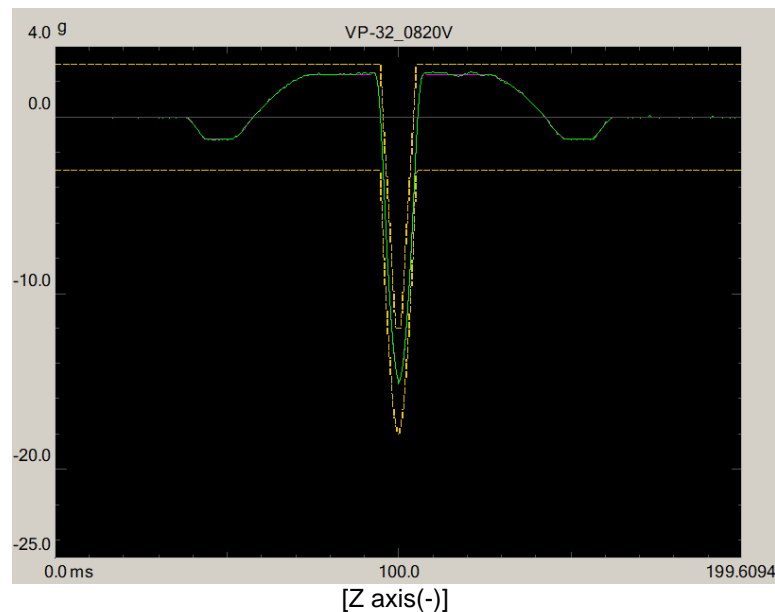
5.3.6. Test data

Test item	Test result
1. Visual inspection / Visual examination - Check damage, breakdown.	No abnormality was found
2. Performance check	No abnormality was found

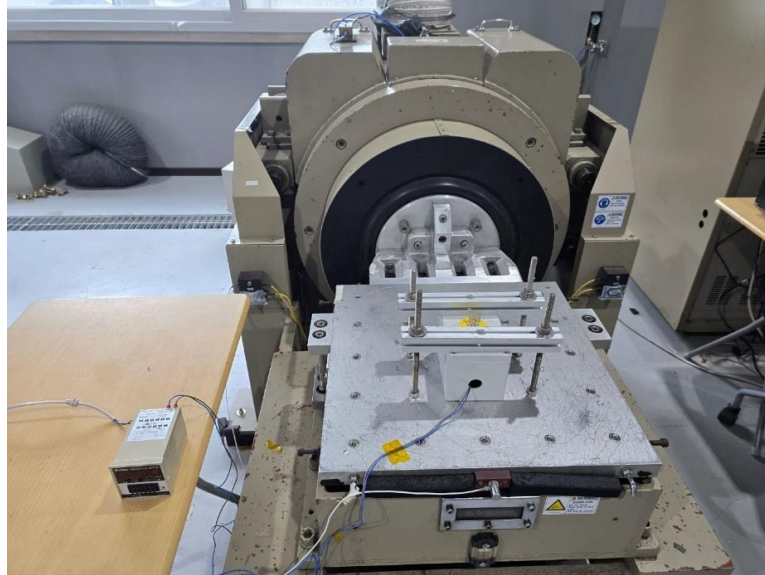
[X axis]

Item	Test Condition
Frequency	(10 ~ 55) Hz
Displacement(p-p)	0.5 mm
Sweep rate	5 min per single-sweep
Test time	30 min per axis
Test type	X, Y, Z axis
Number of samples	1 EA
